The Uniform Building Inspection Report™

Single Family Residence:
5634 East Williams Lane, Leesburg, VA

Inspection Date:
5/9/2003, 8:00:00 AM

Report Number:
05092003

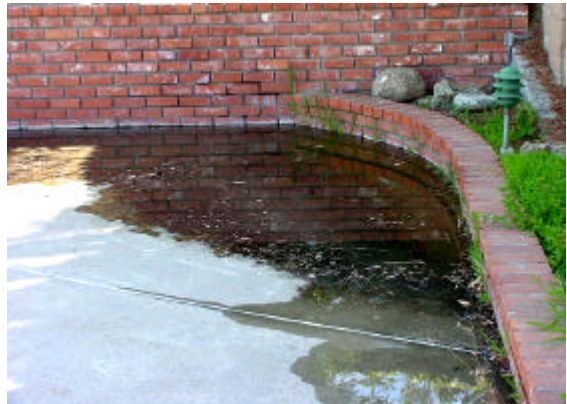
Photo: 0090-(1)

[P] 0090: Landscape / site drainage questionable. Areas of pooling water were noted during the inspection. One depicted was noted on the pool deck. See photo: 0090-(1)

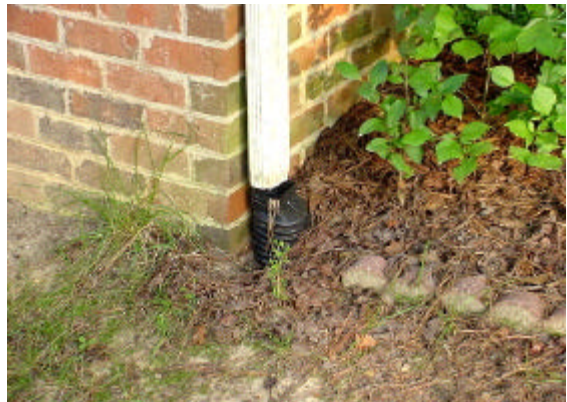
Photo: 0140-(1)

[D] 0140: Downspout extension(s) recommended. It is recommended that all water exiting the downspouts be channeled and/or otherwise directed away from the building. See photo: 0140-(1)

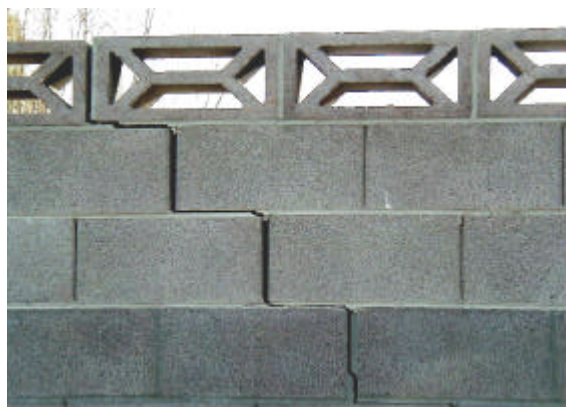
Photo: 0530-(1)

[C] 0530: Masonry fence cracked / tilted / settling / damaged. This was noted at the west fence line. See photo: 0530-(1)

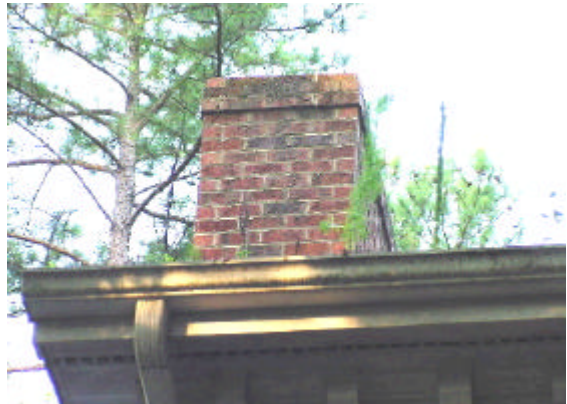
Photo: 1290-(1)

[D] 1290: Gutters need cleaning.
Gutters at the front of the structure have weeds growing inside. Clean as soon as possible to prevent excessive rust and deterioration of the gutters. See photo: 1290-(1)

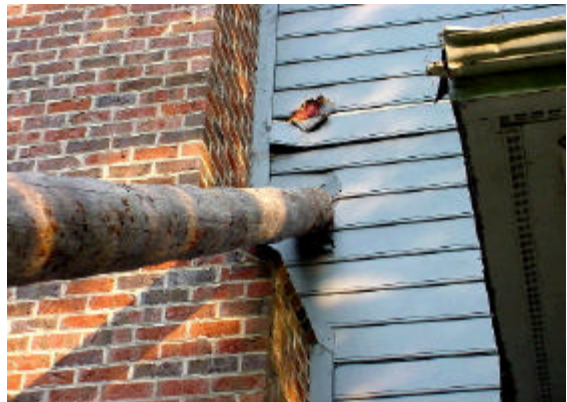
Photo: 1310.02-(1)

[D] 1310.02: Siding holed.
Siding holed by fallen tree. Noted at the right side of the building. See photo: 1310.02-(1)

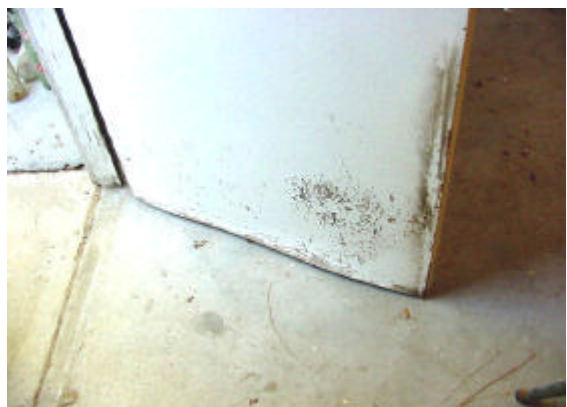
Photo: 1600-(1)

[D] 1600: Door surface delaminated / damaged.
The garage side door skin is delaminating Prepare to replace this door. See photo: 1600-(1)

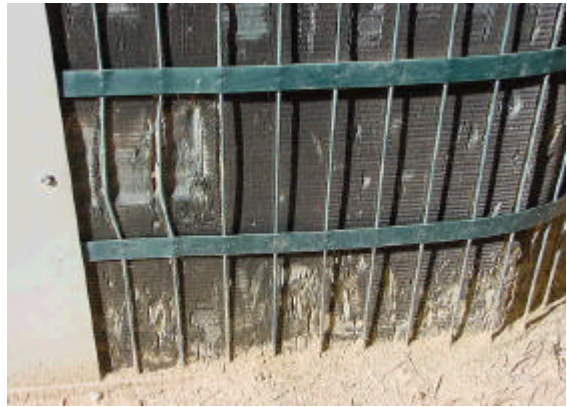
Photo: 2050-(1)

[R] 2050: Evaporator / condenser radiator dirty / damaged / blocked / amiss.
Dirt piled against the #1 compressor must be removed.
Damage to the unit is imminent. See photo: 2050-(1)

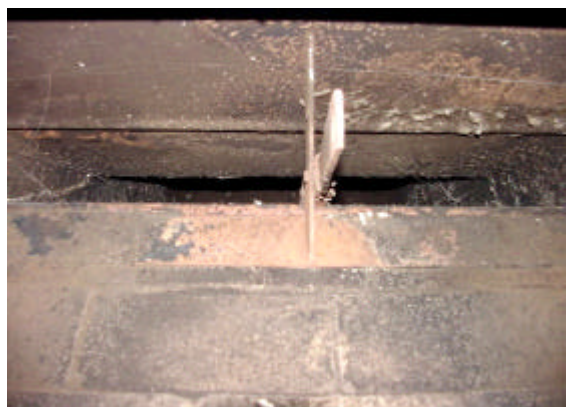
Photo: 2620.03-(1)

[P] 2620.03: Chimney damper balky.
Damper doors should be maintained periodically.
Recommend cleaning and oiling annually. The damper depicted is very difficult to open or close. See photo: 2620.03-(1)

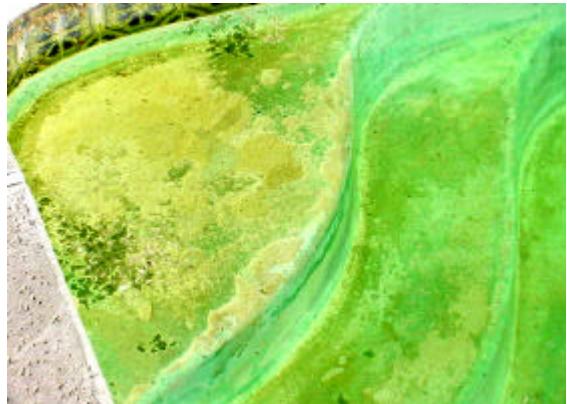
Photo: 3010.04-(1)

[R] 3010.04: Pool finish coating worn.
The pool plaster is heavily worn and may need to be replastered. Please contact a pool refinish company for a second opinion. See photo: 3010.04-(1)

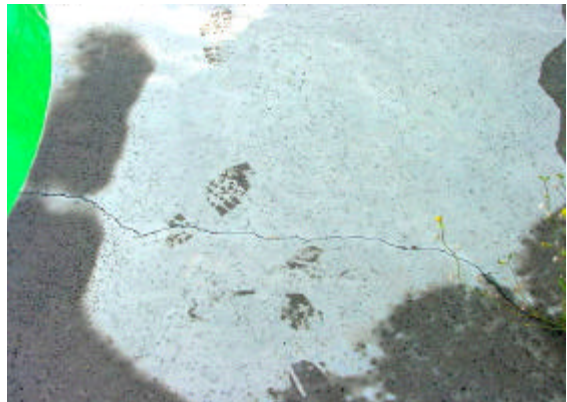
Photo: 3110.02-(1)

[M] 3110.02: Moderate pool deck cracks noted.
See photo: 3110.02-(1)

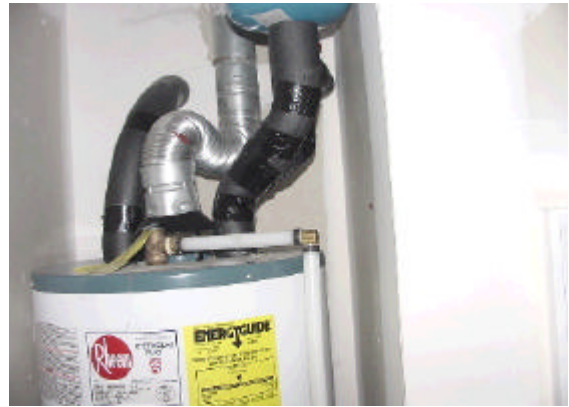
Photo: 4080.01-(1)

[H] 4080.01: Water heater vent improper.
Water heater #2 vent is installed incorrectly. This condition must be corrected as soon as possible as it could pose a fire hazard. See photo: 4080.01-(1)

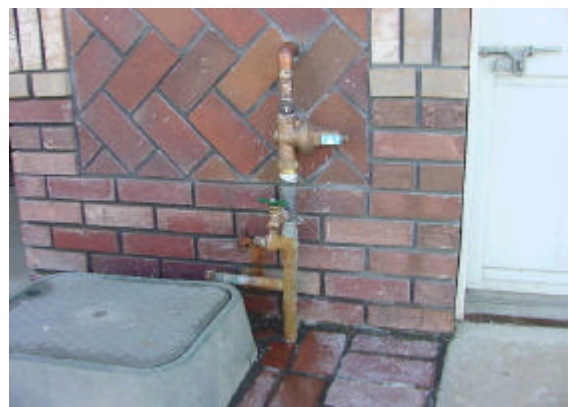
Photo: 4430-(1)

[R] 4430: Water pipes or fittings corroded and/or leaking.
Leaks noted at the main water valve. Corrections advised. See photo: 4430-(1)

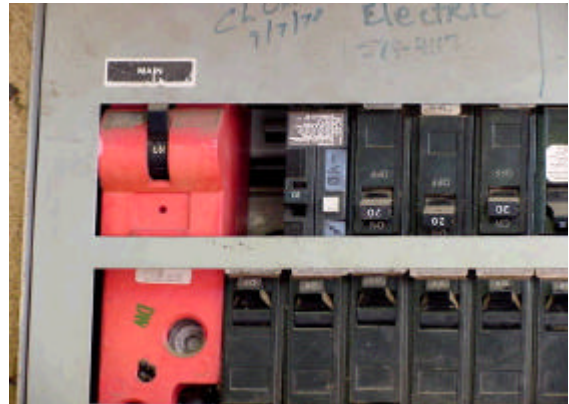
Photo: 5120.01-(1)

[B] 5120.01: Breaker knockout missing from main panel (exposes bus bar).
See photo: 5120.01-(1)

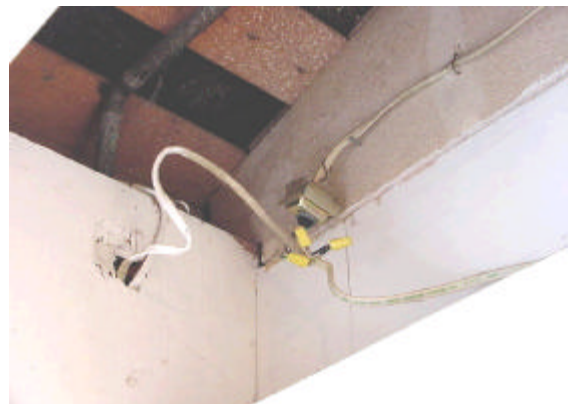
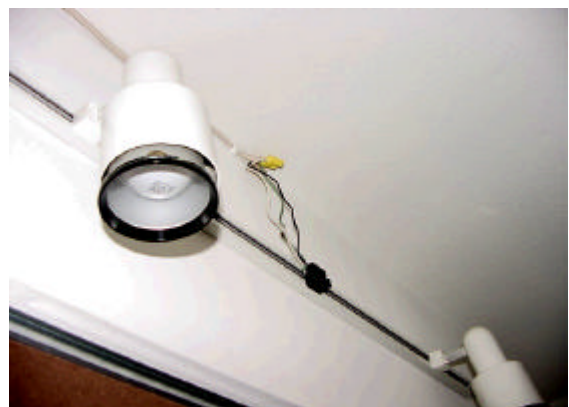
[R] 5470: Electrical additions/modifications noted. Several modifications were noted. Two depicted are above the garage door and in the master bedroom closet. See photos: 5470-(1 and 2)

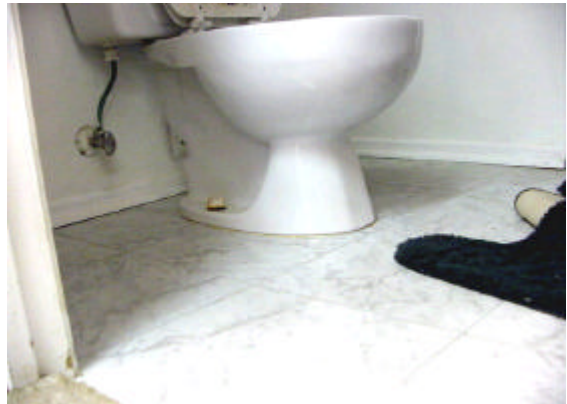
Photo: 6200.01-(1)

[D] 6200.01: Toilet bowl loose on floor.
Noted in the master bath. See photo: 6200.01-(1)

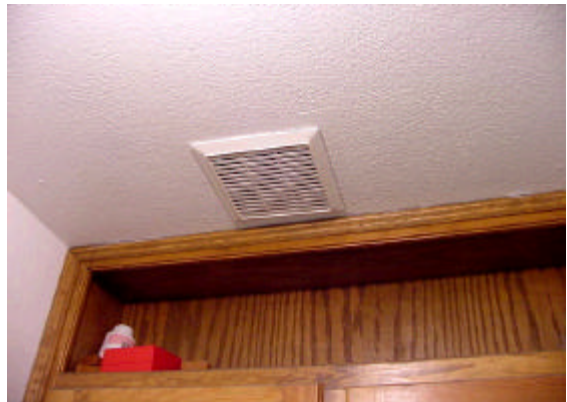
Photo: 6500.01-(1)

[F] 6500.01: Exhaust fan inoperative.
Noted in the downstairs hall bath. See photo: 6500.01-(1)

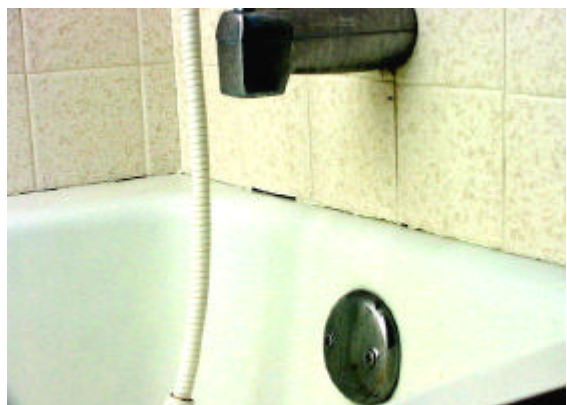
Photo: 6730-(1)

[P] 6730: Caulk tub or shower pan to wall.
Recommended to prevent water damage to the walls and surrounding structure. One depicted is in the master bath.
See photo: 6730-(1)

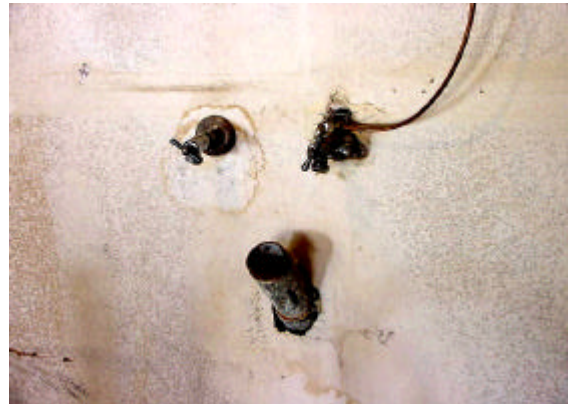
Photo: 7000.01-(1)

[N] 7000.01: Stain noted on interior surface.
This was noted in the garage by the washer valves. See photo: 7000.01-(1)

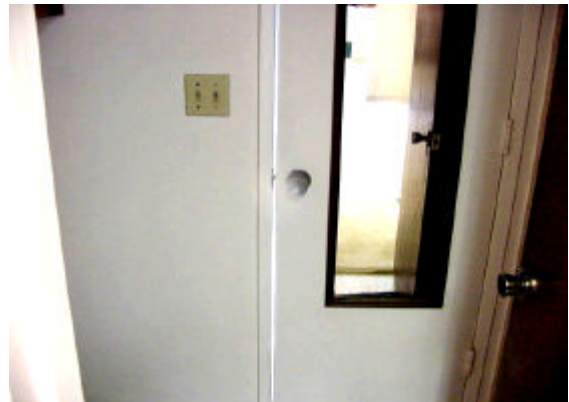
Photo: 7450.01-(1)

[B] 7450.01: Door weather-strip missing.
Noted in the master bath. See photo: 7450.01-(1)

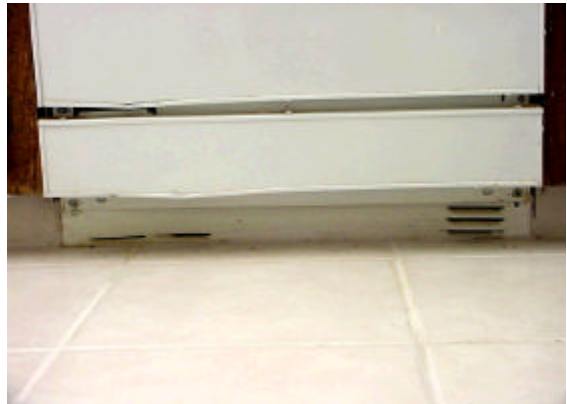
Photo: 8200.02-(1)

[N] 8200.02: Dishwasher cosmetically damaged. The dishwasher is cosmetically damaged and is locked in by floor tile. Removal of the tile of the counter will be necessary when replacing the dishwasher. See photo: 8200.02-(1)

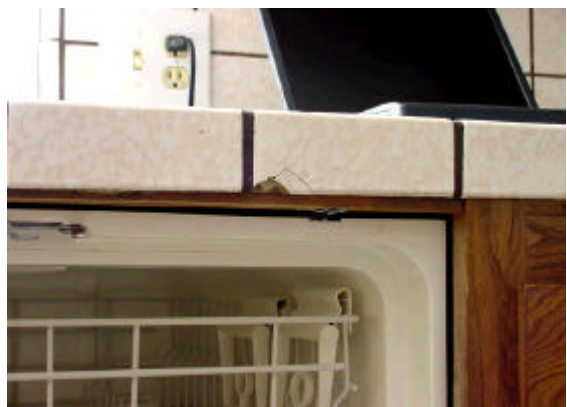
Photo: 8800.01-(1)

[A] 8800.01: Tile or grout cracked. See photo: 8800.01-(1)

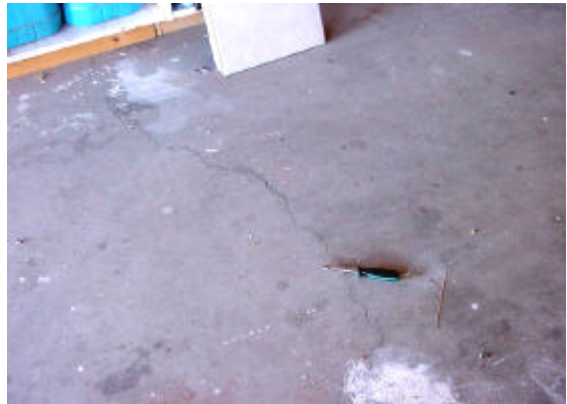
Photo: 9150.01-(1)

[N] 9150.01: Slab cracks noted.
Noted in the garage. See photo: 9150.01-(1)

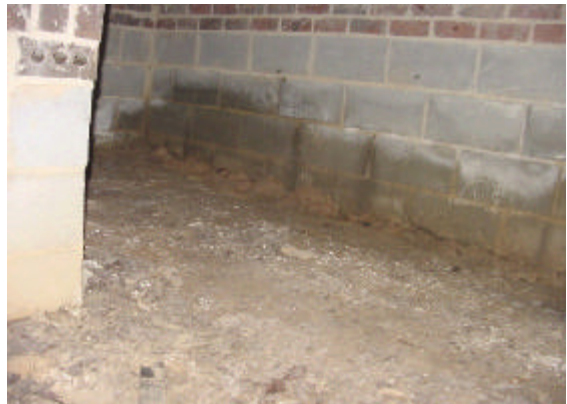
Photo: 9400.10-(1)

[D] 9400.10: Prior or present moisture noted in the crawlspace area.
This may be caused by the lack of downspout extensions.
See photo: 9400.10-(1)

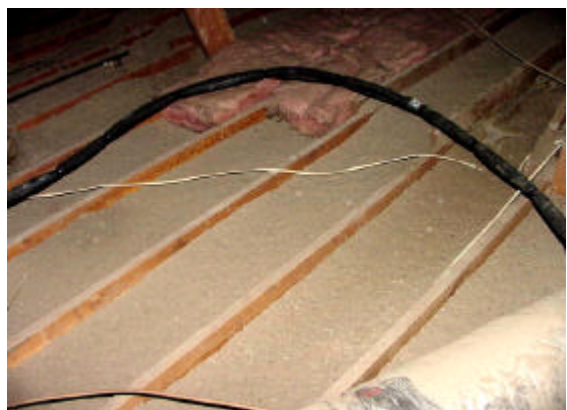
Photo: 9700.01-(1)

[R] [B] [E] 9700.01: Insulation appears insufficient.
The area over the family room appears to not have been fully insulated by the original insulation contractor. See photo: 9700.01-(1)
