The Uniform Building Inspection Report™

Single Family Residence:
5634 East Williams Lane, Leesburg, VA

Inspection Date:
5/9/2003, 8:00:00 AM

Report Number:
05092003

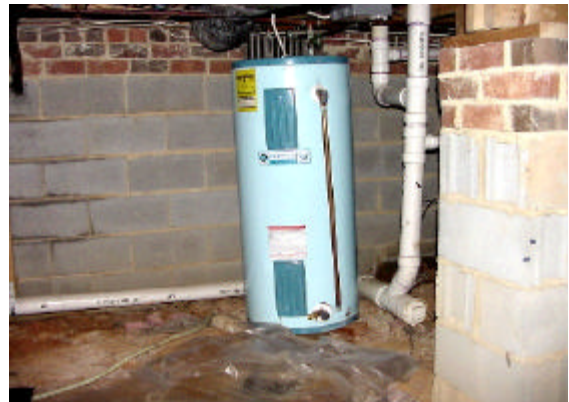
Photo: 4080.01-(1)

[H] 4080.01: Water heater vent improper.
Water heater #2 vent is installed incorrectly. This condition must be corrected as soon as possible as it could pose a fire hazard. See photo: 4080.01-(1)

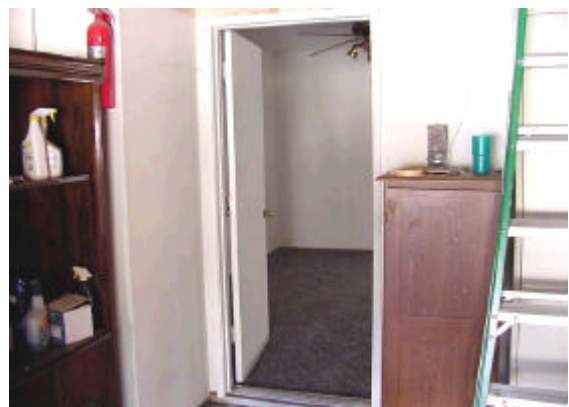
Photo: 7450.01-(1)

[B] 7450.01: Door weather-strip missing.
Noted in the master bath. See photo: 7450.01-(1)
